# Access Compliance Report Public Rights-of-Way (Curb Ramps)

Main Street: CEDARWOOD\_AVE Cross Street: LEDON\_WAY Location: NE

ADA ID: RPRK211005174538 Ramp Type: Type 1 - Perpendicular Diagonal Initial Pass/Fail: Fail Overall Compliance: No Severity Score: 16

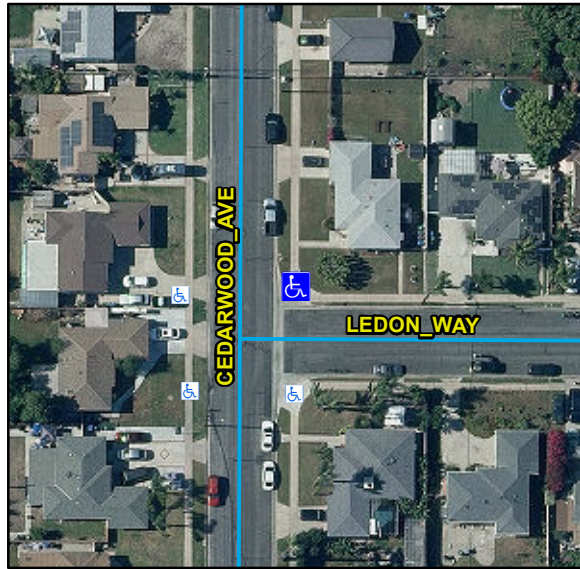
| Compliance | Description | Data | Compliance | Description | Data |
|---|---|---|---|---|---|
| No | Ramp Run Slope (%) | 11.2 | N/A | Flare Slope LT (%) | N/A |
| No | Ramp Cross Slope (%) | 3.5 | N/A | Flare Traversable LT | N/A |

Remove & Replace Curb Ramp With Two New Directional Ramps or Equivalent.

R304.2.2, R304.5.3, STD 1115
