# Access Compliance Report Public Rights-of-Way (Curb Ramps)

Main Street: LEDON\_WAY Cross Street: CEDARWOOD\_AVE Location: SE

ADA ID: RPRK211005174718 Ramp Type: Type 1 - Perpendicular Diagonal Initial Pass/Fail: Fail Overall Compliance: No Severity Score: 15

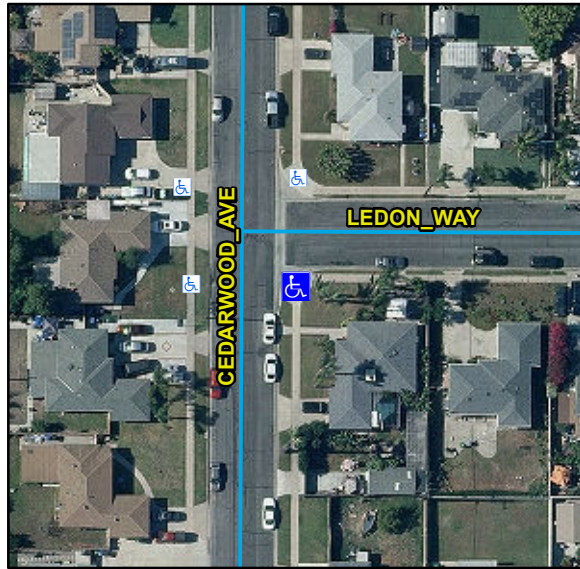
| Compliance | Description | Data | Compliance | Description | Data |
|---|---|---|---|---|---|
| No | Ramp Run Slope (%) | 10.9 | N/A | Flare Slope LT (%) | N/A |

**Remove & Replace Curb Ramp With Two New Directional Ramps or Equivalent.**

**R304.2.2, STD 1115**
