# Access Compliance Report Public Rights-of-Way (Curb Ramps)

Main Street: CEDARWOOD\_AVE Cross Street: DARWIN\_AVE Location: NE

ADA ID: RPRK211005175536 Ramp Type: Type 1 - Perpendicular Diagonal Initial Pass/Fail: Fail Overall Compliance: No Severity Score: 16

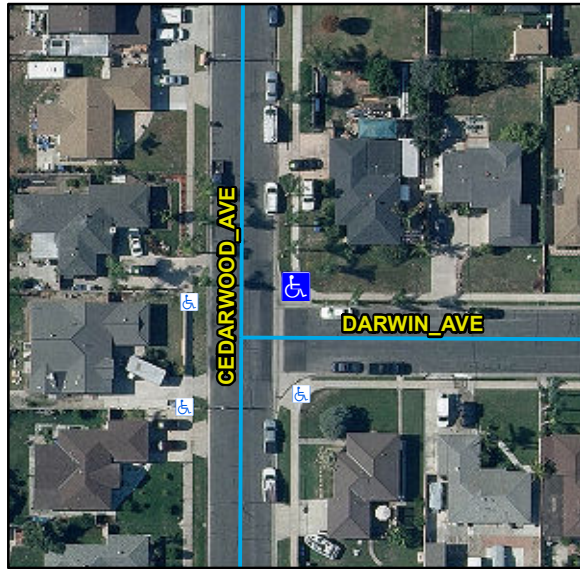
| Compliance | Description | Data | Compliance | Description | Data |
|---|---|---|---|---|---|
| No | Ramp Run Slope (%) | 10.7 | N/A | Flare Slope LT (%) | N/A |
| No | Ramp Cross Slope (%) | 2.5 | N/A | Flare Traversable LT | N/A |

Remove & Replace Curb Ramp With Two New Directional Ramps or Equivalent.

R304.2.2, R304.5.3, STD 1115
