# Access Compliance Report Public Rights-of-Way (Curb Ramps)

Main Street: E\_KIRKWOOD\_AVE Cross Street: S\_NEWHAVEN\_DR Location: SE

ADA ID: RPRK211006180726 Ramp Type: Type 1 - Perpendicular Diagonal Initial Pass/Fail: Fail Overall Compliance: No Severity Score: 15

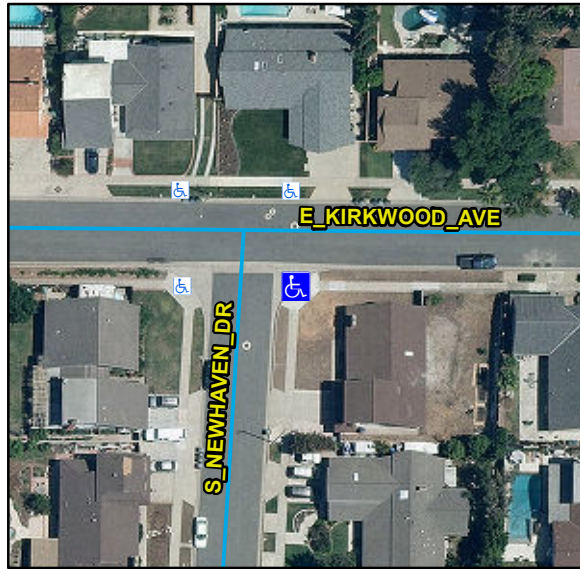
| Compliance | Description | Data | Compliance | Description | Data |
|---|---|---|---|---|---|
| No | Ramp Run Slope (%) | 11.2 | N/A | Flare Slope LT (%) | N/A |

Remove & Replace Curb Ramp With Two New Directional Ramps or Equivalent.

R304.2.2, STD 1115
