# Access Compliance Report Public Rights-of-Way (Curb Ramps)

Main Street: E\_FAIRHAVEN\_AVE Cross Street: S\_CEDARWOOD\_ST Location: N

ADA ID: RPRK211007113724 Ramp Type: Type 1 - Perpendicular Diagonal Initial Pass/Fail: Fail Overall Compliance: No Severity Score: 2

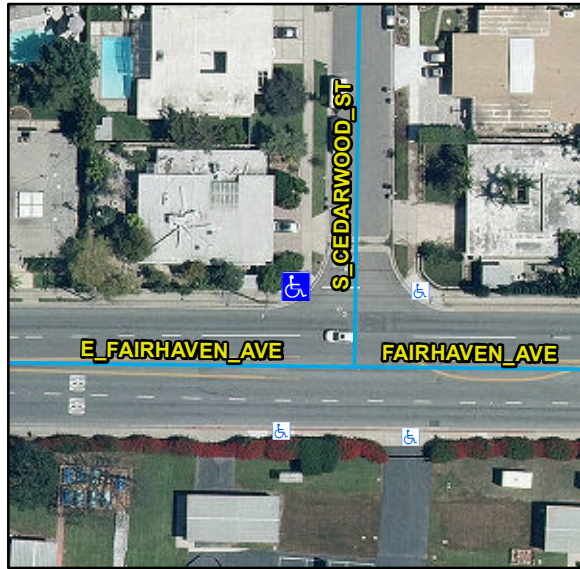
R304.2.2, R304.5.3, STD 1115

| Compliance | Description | Data | Compliance | Description | Data |
|---|---|---|---|---|---|
| No | Ramp Cross Slope (%) | 2.5 | N/A | Flare Traversable LT | N/A |

Remove & Replace Curb Ramp With Two New Directional Ramps or Equivalent.
