# Access Compliance Report Public Rights-of-Way (Curb Ramps)

Main Street: NEWPORT\_AVE Cross Street: EL\_CAMINO\_LN Location: NE

ADA ID: RPRK211007131929 Ramp Type: Type 1 - Perpendicular Diagonal Initial Pass/Fail: Fail Overall Compliance: No Severity Score: 30

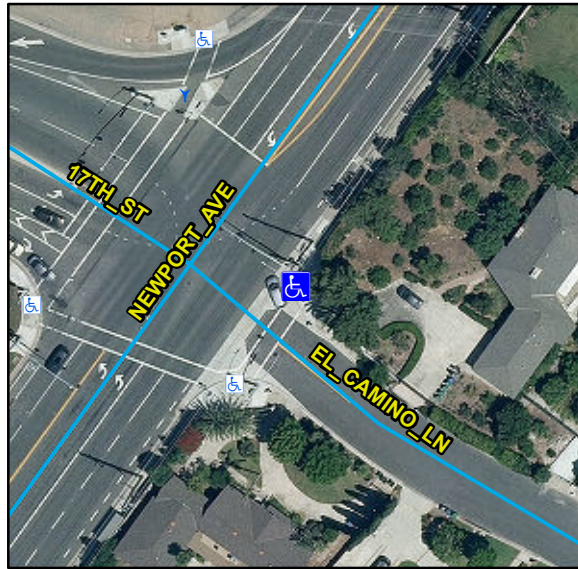
| Compliance | Description | Data | Compliance | Description | Data |
|---|---|---|---|---|---|
| No | Ramp Run Slope (%) | 12.7 | N/A | Flare Slope LT (%) | N/A |

Remove & Replace Curb Ramp With Two New Directional Ramps or Equivalent. Restripe Crosswalk.
