# Access Compliance Report Public Rights-of-Way (Curb Ramps)

Main Street: EL\_CAMINO\_LN Cross Street: NEWPORT\_AVE Location: SE

ADA ID: RPRK211007132439 Ramp Type: Type 1 - Perpendicular Diagonal Initial Pass/Fail: Fail Overall Compliance: No Severity Score: 15

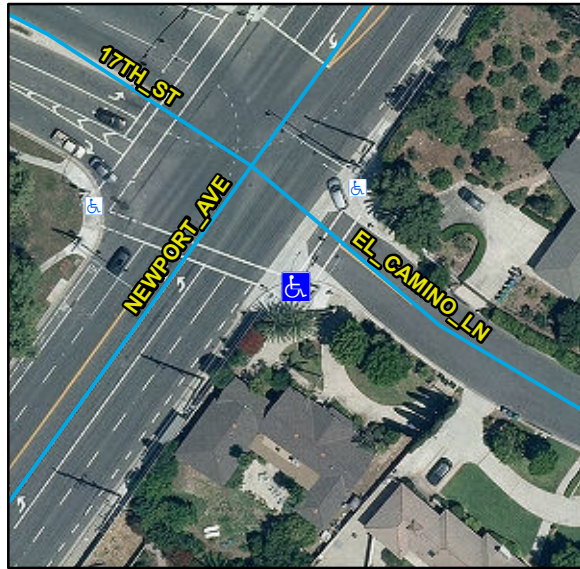
R304.2.2, R204.3, STD 1115

| Compliance | Description | Data | Compliance | Description | Data |
|---|---|---|---|---|---|
| No | Ramp Run Slope (%) | 9.8 | N/A | Flare Slope LT (%) | N/A |

Remove & Replace Curb Ramp With Two New Directional Ramps or Equivalent.
