# Access Compliance Report Public Rights-of-Way (Curb Ramps)

Main Street: GLENMERE\_DR Cross Street: CASTLEGATE\_LN Location: E

ADA ID: RPRK211008133137 Ramp Type: Type 1 - Perpendicular Diagonal Initial Pass/Fail: Fail Overall Compliance: No Severity Score: 30

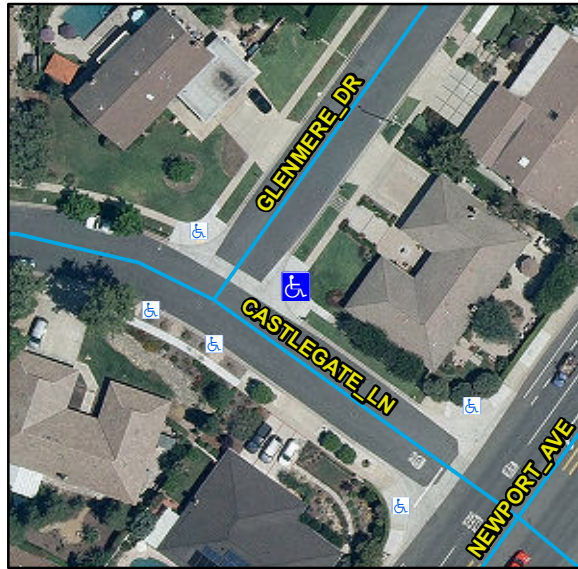
| Compliance | Description | Data | Compliance | Description | Data |
|---|---|---|---|---|---|
| No | Ramp Run Slope (%) | 11.6 | N/A | Flare Slope LT (%) | N/A |
| No | Ramp Cross Slope (%) | 5.7 | N/A | Flare Traversable LT | N/A |

Remove & Replace Curb Ramp With Two New Directional Ramps or Equivalent.
