# Access Compliance Report Public Rights-of-Way (Curb Ramps)

| Main Street: NEWPORT_AVE | | Cross Street: LA_LOMA_DR | | Location: | SE |
| ADA ID: RPRK211008141857 | Ramp Type:Type 1 - Perpendicular Diagonal Initial Pass/Fail: Fail | | Overall Compliance: No | Severity Score: | 15 |

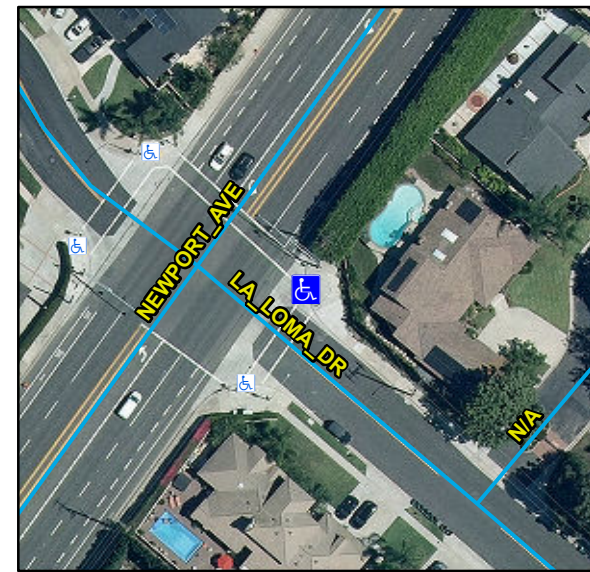
R304.2.2, STD 1115

| Compliance | Description | Data | Compliance | Description | Data |
|---|---|---|---|---|---|
| No | Ramp Run Slope (%) | 11.5 | N/A | Flare Slope LT (%) | N/A |

**Remove & Replace Curb Ramp With Two New Directional Ramps or Equivalent.**
