# Access Compliance Report Public Rights-of-Way (Curb Ramps)

Main Street: CASTLEGATE\_LN Cross Street: ARROYO\_AVE Location: N

ADA ID: RPRK211011105620 Ramp Type: Type 1 - Perpendicular Diagonal Initial Pass/Fail: Fail Overall Compliance: No Severity Score: 32

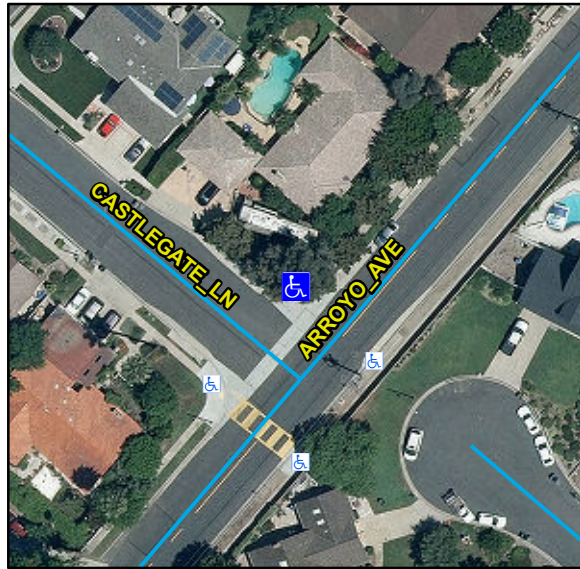
| Compliance | Description | Data | Compliance | Description | Data |
|---|---|---|---|---|---|
| No | Ramp Run Slope (%) | 13.8 | N/A | Flare Slope LT (%) | N/A |
| No | Ramp Cross Slope (%) | 2.1 | N/A | Flare Traversable LT | N/A |

**Remove & Replace Curb Ramp With Two New Directional Ramps or Equivalent.**
