# Access Compliance Report Public Rights-of-Way (Curb Ramps)

Main Street: ARROYO\_AVE Cross Street: CASTLEGATE\_LN Location: W

ADA ID: RPRK211011105810 Ramp Type: Type 1 - Perpendicular Diagonal Initial Pass/Fail: Fail Overall Compliance: No Severity Score: 16

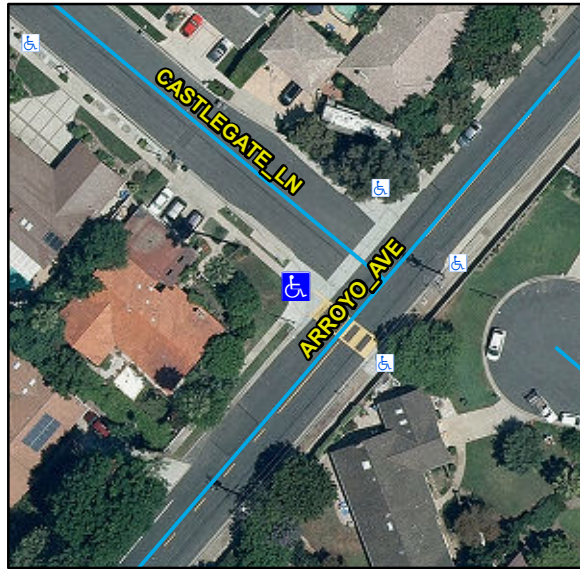
| Compliance | Description | Data | Compliance | Description | Data |
|---|---|---|---|---|---|
| No | Ramp Run Slope (%) | 11.6 | N/A | Flare Slope LT (%) | N/A |
| No | Ramp Cross Slope (%) | 2.8 | N/A | Flare Traversable LT | N/A |

Remove & Replace Curb Ramp With Two New Directional Ramps or Equivalent.
