# Access Compliance Report Public Rights-of-Way (Curb Ramps)

Main Street: ARROYO\_AVE Cross Street: CASTLEGATE\_LN Location: S

ADA ID: RPRK211011110018 Ramp Type: Type 1 - Perpendicular Initial Pass/Fail: Fail Overall Compliance: No Severity Score: 30

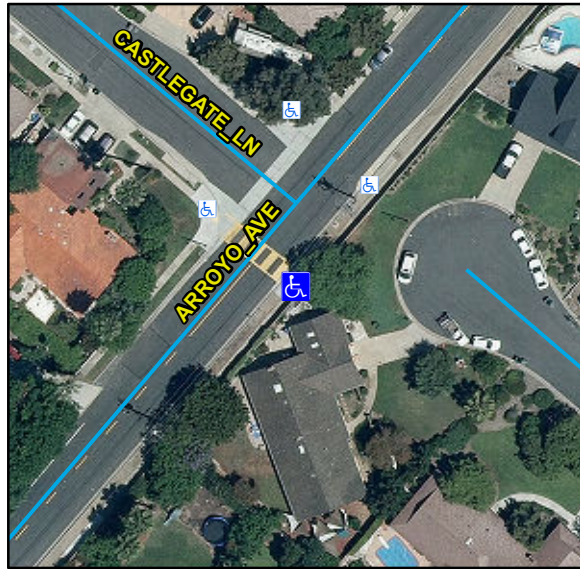
| Compliance | Description | Data | Compliance | Description | Data |
|---|---|---|---|---|---|
| No | Ramp Run Slope (%) | 13.1 | N/A | Flare Slope LT (%) | N/A |

Remove & Replace Entire Ramp.

R304.2.2, STD 1115
