# Access Compliance Report Public Rights-of-Way (Curb Ramps)

| Main Street: ARBOLADA_WAY | | Cross Street: PROSPECT_AVE | | Location: | SE |
| ADA ID: RPRK211011123906 | Ramp Type:Type 1 - Perpendicular Diagonal | | Initial Pass/Fail: Fail | Overall Compliance: No | Severity Score: 30 |

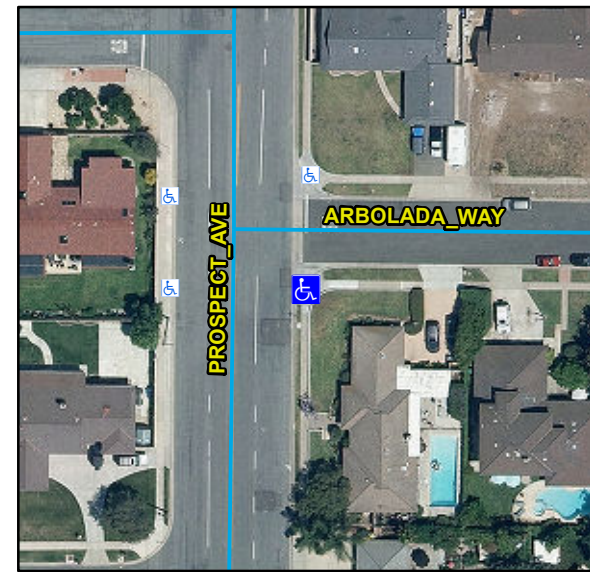
**R204.3, R304.2.2, STD 1115**

**Remove & Replace Curb Ramp With Two New Directional Ramps or Equivalent.**
