# Access Compliance Report Public Rights-of-Way (Curb Ramps)

Main Street: PROSPECT\_AVE Cross Street: ARBOLADA\_WAY Location: NE

ADA ID: RPRK211011124200 Ramp Type: Type 1 - Perpendicular Diagonal Initial Pass/Fail: Fail Overall Compliance: No Severity Score: 16

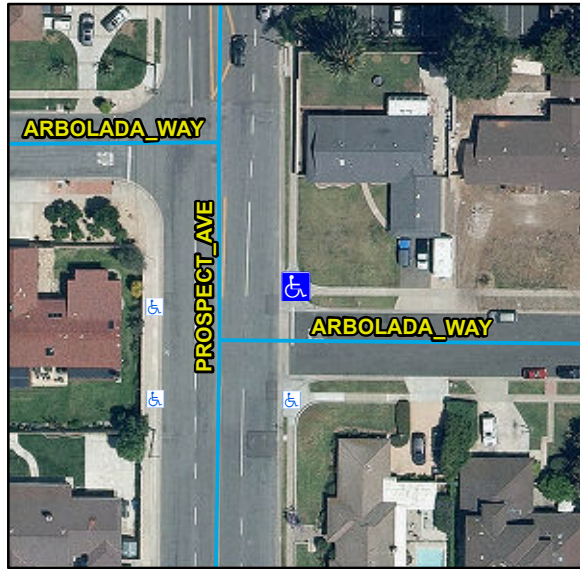
| Compliance | Description | Data | Compliance | Description | Data |
|---|---|---|---|---|---|
| No | Ramp Run Slope (%) | 10 | N/A | Flare Slope LT (%) | N/A |
| No | Ramp Cross Slope (%) | 2.3 | N/A | Flare Traversable LT | N/A |

Remove & Replace Curb Ramp With Two New Directional Ramps or Equivalent.

R304.2.2, R304.5.3, STD 1115
