# Access Compliance Report Public Rights-of-Way (Curb Ramps)

| Main Street: Foothill_BlvD | | Cross Street: Arroyo_Ave | | Location: | SE |
| ADA ID: RPRK211012122152 | Ramp Type:Type 1 - Perpendicular | Initial Pass/Fail: Fail | Overall Compliance: No | Severity Score: | 30 |

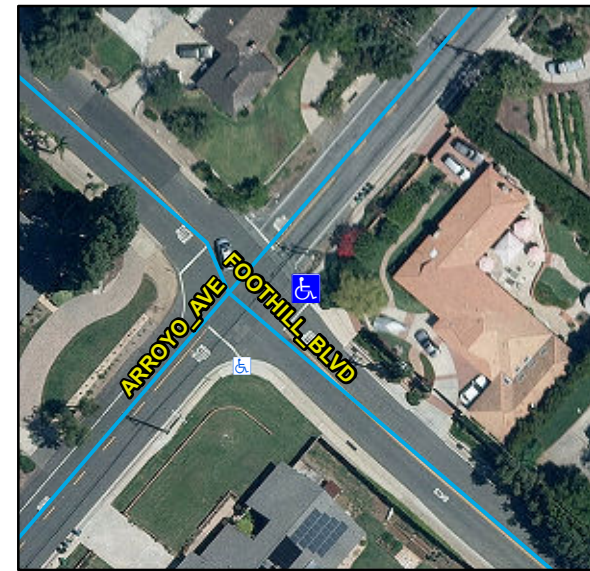
| Compliance | Description | Data | Compliance | Description | Data |
|---|---|---|---|---|---|
| No | Ramp Run Slope (%) | 14.4 | N/A | Flare Slope LT (%) | N/A |

**Remove & Replace Entire Ramp.**

**R304.2.2, STD 1115**
