# Access Compliance Report Public Rights-of-Way (Curb Ramps)

Main Street: LA\_LOMA\_DR Cross Street: RYCROFT\_RD Location: SW

ADA ID: RPRK211012134126 Ramp Type: Type 1 - Perpendicular Diagonal Initial Pass/Fail: Fail Overall Compliance: No Severity Score: 15

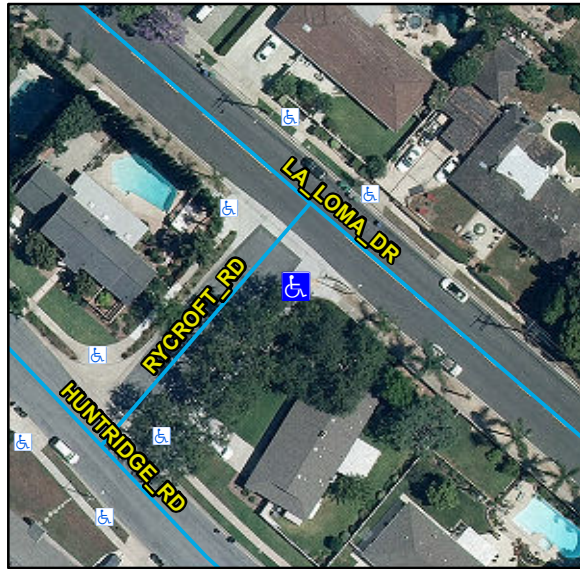
| Compliance | Description | Data | Compliance | Description | Data |
|---|---|---|---|---|---|
| No | Ramp Run Slope (%) | 9.6 | N/A | Flare Slope LT (%) | N/A |

Remove & Replace Curb Ramp With Two New Directional Ramps or Equivalent.

R304.2.2, STD 1115
