# Access Compliance Report

## Public Rights-of-Way

Main Street: LA\_LOMA\_DR Cross Street: PINCIAN\_WAY Location: NE

ADA ID: RPRK211012180058 Ramp Type: Type 1 - Perpendicular Diagonal Initial Pass/Fail: Fail Overall Compliance: No Severity Score: 15

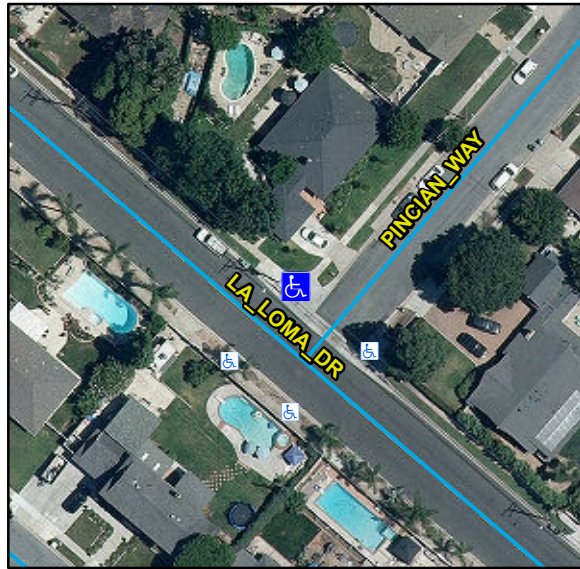
| Compliance | Description | Data | Compliance | Description | Data |
|---|---|---|---|---|---|
| No | Ramp Run Slope (%) | 11 | N/A | Flare Slope LT (%) | N/A |

**Remove & Replace Curb Ramp With Two New Directional Ramps or Equivalent.**

**R304.2.2, STD 1115**
