# Access Compliance Report Public Rights-of-Way (Curb Ramps)

Main Street: PINCIAN\_WAY Cross Street: LA\_LOMA\_DR Location: SE

ADA ID: RPRK211012180305 Ramp Type: Type 1 - Perpendicular Diagonal Initial Pass/Fail: Fail Overall Compliance: No Severity Score: 15

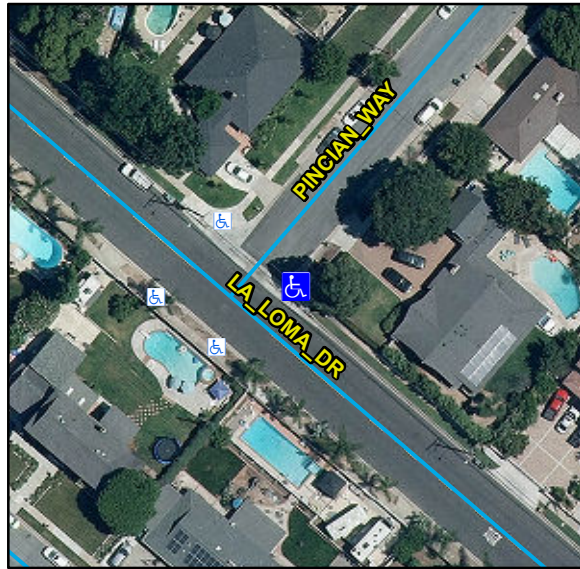
| Compliance | Description | Data | Compliance | Description | Data |
|---|---|---|---|---|---|
| No | Ramp Run Slope (%) | 11.6 | N/A | Flare Slope LT (%) | N/A |

Remove & Replace Curb Ramp With Two New Directional Ramps or Equivalent.

R304.2.2, STD 1115
