# Access Compliance Report Public Rights-of-Way (Curb Ramps)

Main Street: ARROYO\_AVE Cross Street: HYDE\_PARK\_DR Location: NW

ADA ID: RPRK211013113257 Ramp Type: Type 1 - Perpendicular Diagonal Initial Pass/Fail: Fail Overall Compliance: No Severity Score: 2

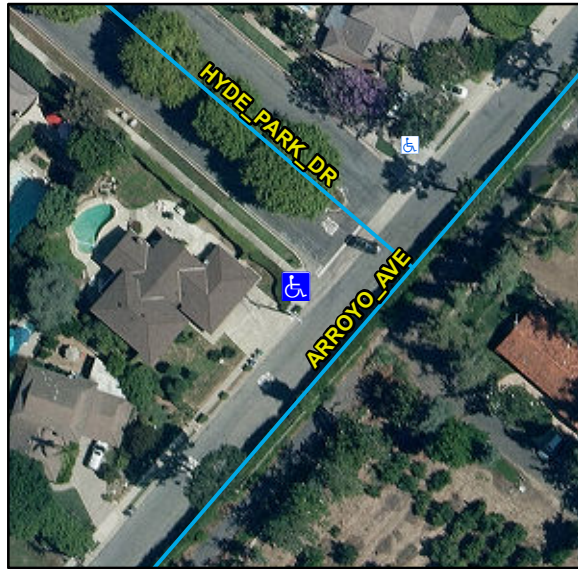
| Compliance | Description | Data | Compliance | Description | Data |
|---|---|---|---|---|---|
| No | Ramp Cross Slope (%) | 4 | N/A | Flare Traversable LT | N/A |

Remove & Replace Curb Ramp With Two New Directional Ramps or Equivalent.
