# Access Compliance Report Public Rights-of-Way (Curb Ramps)

Main Street: MUMFORD\_RD Cross Street: ARROYO\_AVE Location: SW

ADA ID: RPRK211013115054 Ramp Type: Type 1 - Perpendicular Diagonal Initial Pass/Fail: Fail Overall Compliance: No Severity Score: 30

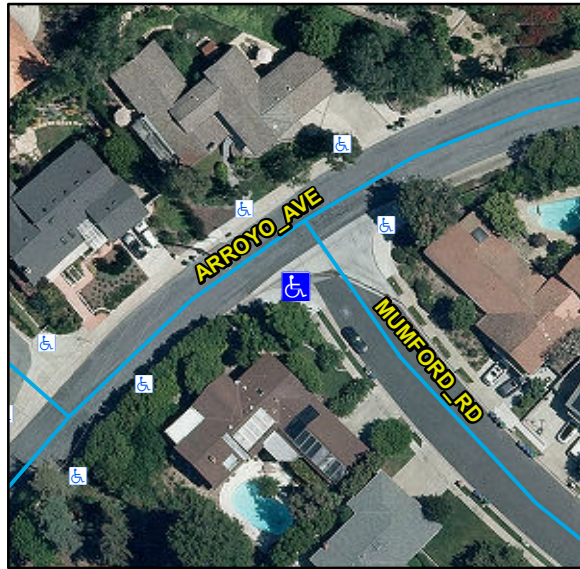
| Compliance | Description | Data | Compliance | Description | Data |
|---|---|---|---|---|---|
| No | Ramp Cross Slope (%) | 13.5 | N/A | Flare Traversable LT | N/A |

Remove & Replace Curb Ramp With Two New Directional Ramps or Equivalent.
