# Access Compliance Report Public Rights-of-Way (Curb Ramps)

Main Street: CORONEL\_RD Cross Street: ARROYO\_AVE Location: SW

ADA ID: RPRK211013124358 Ramp Type: Type 4 - Parallel Initial Pass/Fail: Fail Overall Compliance: No Severity Score: 2

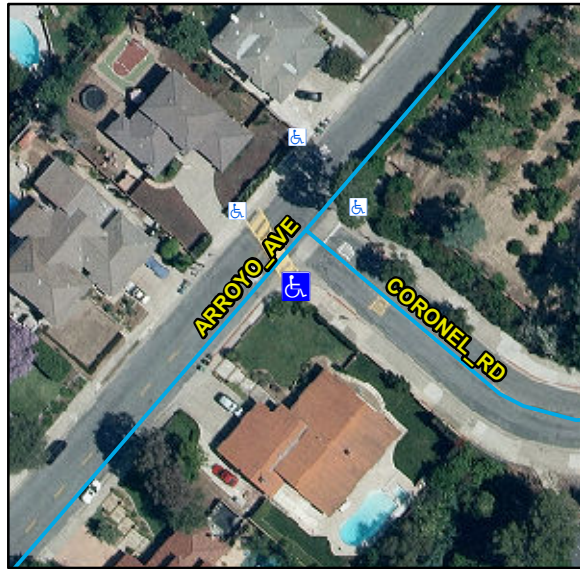
| Compliance | Description | Data | Compliance | Description | Data |
|---|---|---|---|---|---|
| No | Ramp Cross Slope LT (%) | 3.3 | No | Ramp Cross Slope RT (%) | 4.7 |
| No | Gutter Lip Height (in) | 0.5 | | Road Run Slope (%) | 4.6 |

Remove & Replace Curb Ramp With Two New Directional Ramps or Equivalent. Grind Gutter Lip.

R204.3, R304.5.3, R302.7.2, STD 1115
