# Access Compliance Report Public Rights-of-Way (Curb Ramps)

Main Street: LA LIMONAR\_RD Cross Street: ARROYO\_AVE Location: NE

ADA ID: RPRK211013124916 Ramp Type: Type 1 - Perpendicular Diagonal Initial Pass/Fail: Fail Overall Compliance: No Severity Score: 2

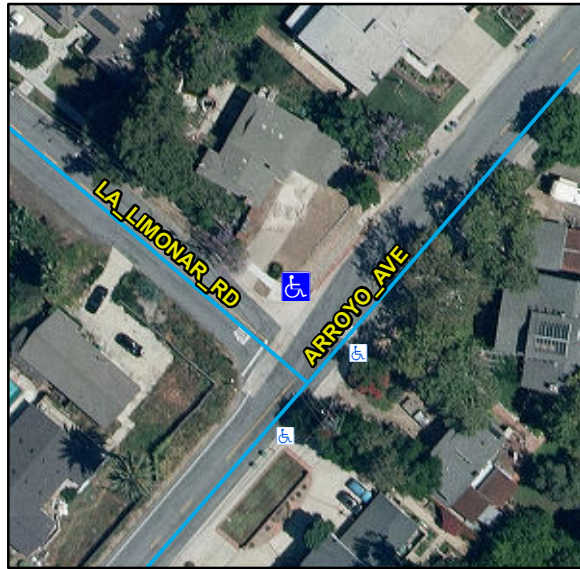
| Compliance | Description | Data | Compliance | Description | Data |
|---|---|---|---|---|---|
| No | Ramp Cross Slope (%) | 2.2 | N/A | Flare Traversable LT | N/A |

**Remove & Replace Curb Ramp With Two New Directional Ramps or Equivalent.**

**R304.5.3, STD 1115**
