# Access Compliance Report Public Rights-of-Way (Curb Ramps)

Main Street: MELVIN\_WY Cross Street: RED\_HILL\_AVE Location: E

ADA ID: RPRK211014142637 Ramp Type: Type 1 - Perpendicular Initial Pass/Fail: Fail Overall Compliance: No Severity Score: 16

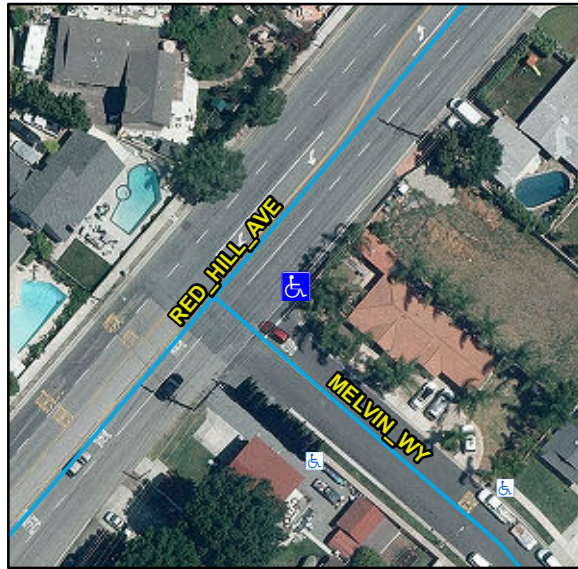
| Compliance | Description | Data | Compliance | Description | Data |
|---|---|---|---|---|---|
| No | Ramp Cross Slope (%) | 3 | N/A | Flare Traversable LT | N/A |
| No | Overall Surface Condition: | Poor | No | Perp Joint Present | No |

Remove & Replace Entire Ramp.

R204.3, R304.5.3, R302.7, STD 1115
