# Access Compliance Report Public Rights-of-Way (Curb Ramps)

Main Street: WOODSONG Cross Street: MEANDERING\_TRAIL Location: W

ADA ID: RPRK211018153655 Ramp Type: Type 1 - Perpendicular Diagonal Initial Pass/Fail: Fail Overall Compliance: No Severity Score: 30

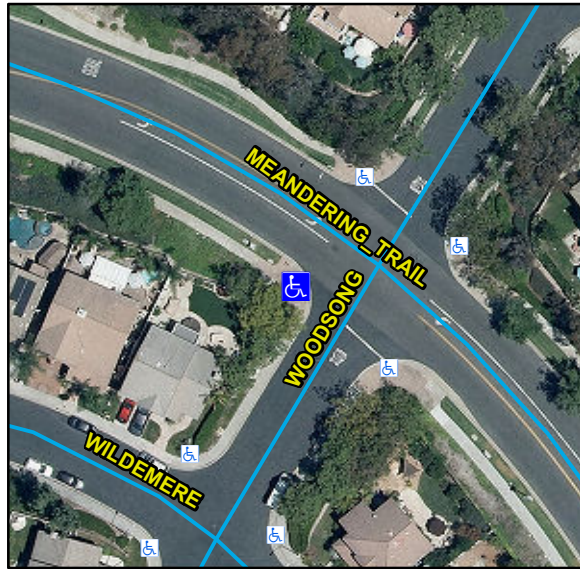
| Compliance | Description | Data | Compliance | Description | Data |
|---|---|---|---|---|---|
| No | Ramp Cross Slope (%) | 7.9 | N/A | Flare Traversable LT | N/A |

Remove & Replace Curb Ramp With Two New Directional Ramps or Equivalent.

R304.2.2, R204.3, R304.5.3, STD 1115
