# Access Compliance Report Public Rights-of-Way (Curb Ramps)

Main Street: **OSO\_PKWY** Cross Street: **ANTONIO\_PKWY** Location: **NW**

ADA ID: **RPRK211019122813** Ramp Type: **Type 1 - Perpendicular** Initial Pass/Fail: **Fail** Overall Compliance: **No** Severity Score: **16**

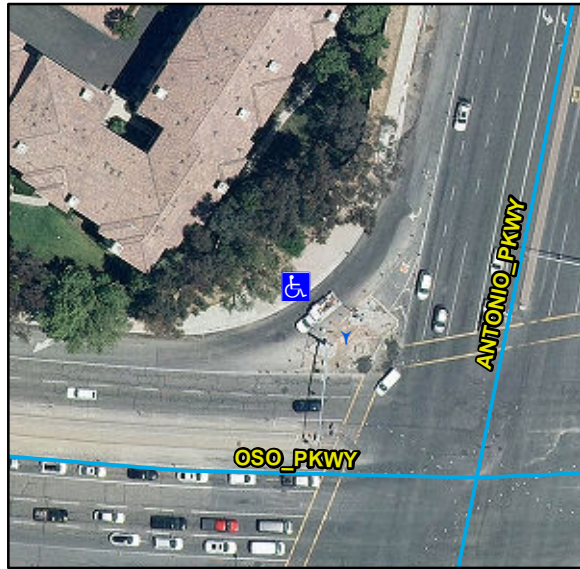
| Compliance | Description | Data | Compliance | Description | Data |
|---|---|---|---|---|---|
| <b>No</b> | Ramp Run Slope (%) | <b>8.8</b> | <b>N/A</b> | Flare Slope LT (%) | <b>N/A</b> |

**Remove & Replace Entire Ramp.**

**R304.2.2, STD 1115**
