Access Compliance Report Public Rights-of-Way (Curb Ramps)

Main Street: MEANDERING_TRAIL **Cross Street:** OSO_PKWY **Location:** SW

ADA ID: RPRK211019150223 **Ramp Type:** Type 4 - Parallel **Initial Pass/Fail:** Fail **Overall Compliance:** No **Severity Score:** 30

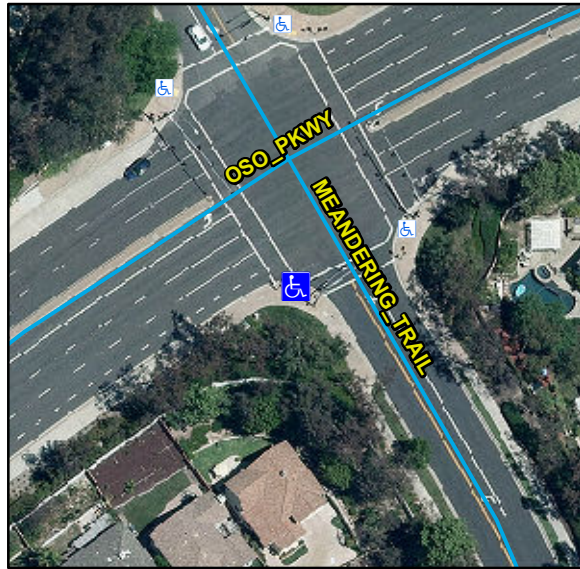
Compliance	Description	Data	Compliance	Description	Data
N/A	Ramp Length LT (in)	114	N/A	Ramp Length RT (in)	110
Yes	Ramp Width LT (in)	100	Yes	Ramp Width RT (in)	100
Yes	Ramp Run Slope LT (%)	4.3	Yes	Ramp Run Slope RT (%)	0.4
No	Ramp Cross Slope LT (%)	7.3	No	Ramp Cross Slope RT (%)	6
N/A	Landing Present	N/A	N/A	DWS Provided	N/A
N/A	Landing Length (in)	N/A	N/A	DWS Contrast	N/A
N/A	Landing Width (in)	N/A	N/A	DWS Length (in)	N/A
N/A	Landing Run Slope (%)	N/A	N/A	DWS Full Width	N/A
N/A	Landing Cross Slope (%)	N/A		DWS Offset Type	N/A
N/A	Landing Movement Obstructed?	N/A	N/A	DWS Offset Left (in)	N/A
	Landing Movement Type	N/A	N/A	DWS Offset Right (in)	N/A
N/A	Landing Shared	N/A			
N/A	Clear Space	Yes			
N/A	Clear Space To Crosswalk (in)	48			
N/A	Marked Crosswalk 1	Yes	N/A	Marked Crosswalk 2	Yes
	Crossing 1 Direction	E		Crossing 2 Direction	N
N/A	Marked Crosswalk 1 Width (in)	144		Marked Crosswalk 2 Width (in)	144

Possible Solutions:
Remove & Replace Curb Ramp With Two New Directional Ramps or Equivalent.
