# Access Compliance Report Public Rights-of-Way (Curb Ramps)

Main Street: BANCROFT\_ST Cross Street: WALDEN\_ST Location: NW

ADA ID: RPRK211020172500 Ramp Type: Type 4 - Parallel Initial Pass/Fail: Fail Overall Compliance: No Severity Score: 2

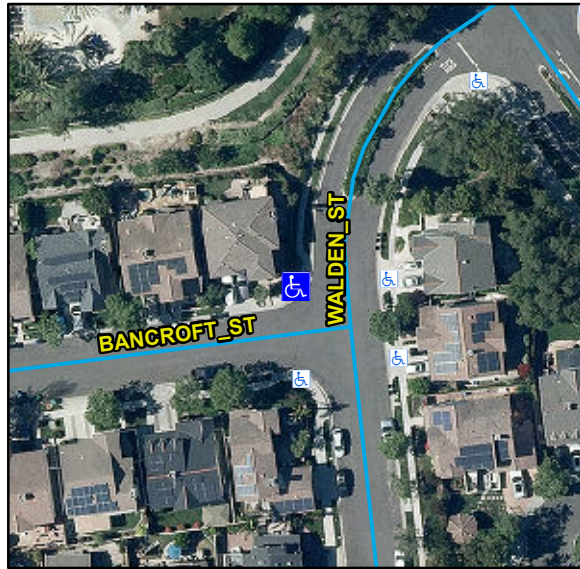
| Compliance | Description | Data | Compliance | Description | Data |
|---|---|---|---|---|---|
| Yes | Ramp Cross Slope LT (%) | 1.1 | No | Ramp Cross Slope RT (%) | 3.7 |

**Remove & Replace Curb Ramp With Two New Directional Ramps or Equivalent.**
