# Access Compliance Report Public Rights-of-Way (Curb Ramps)

Main Street: WALDEN\_ST Cross Street: BANCROFT\_ST Location: SW

ADA ID: RPRK211020172724 Ramp Type: Type 4 - Parallel Initial Pass/Fail: Fail Overall Compliance: No Severity Score: 15

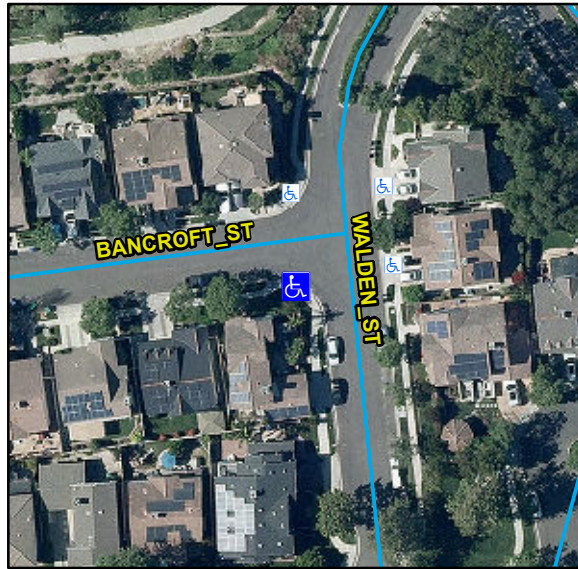
| Compliance | Description | Data | Compliance | Description | Data |
|---|---|---|---|---|---|
| No | Ramp Run Slope LT (%) | 10.7 | Yes | Ramp Run Slope RT (%) | 2.2 |

**Remove & Replace Curb Ramp With Two New Directional Ramps or Equivalent.**

**R204.3, R304.3.2, STD 1115**
