# Access Compliance Report Public Rights-of-Way (Curb Ramps)

Main Street: ACANTHUS Cross Street: MORNING\_TRAIL Location: NW

ADA ID: RPRK211021123206 Ramp Type: Type 4 - Parallel Initial Pass/Fail: Fail Overall Compliance: No Severity Score: 15

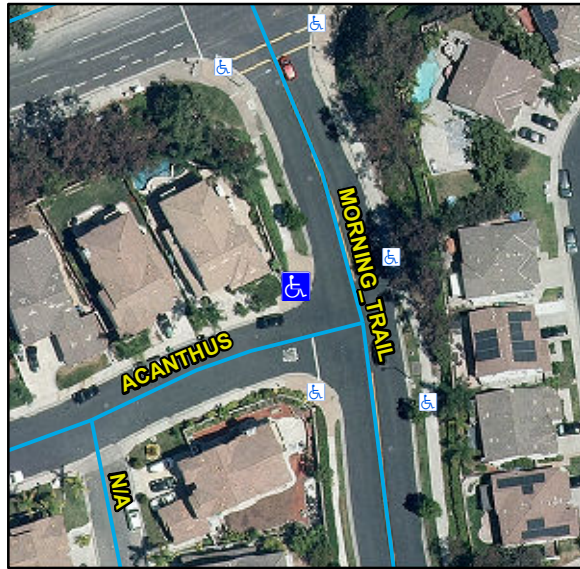
| Compliance | Description | Data | Compliance | Description | Data |
|---|---|---|---|---|---|
| No | Ramp Cross Slope LT (%) | 6.8 | No | Ramp Cross Slope RT (%) | 6.4 |

Remove & Replace Curb Ramp With Two New Directional Ramps or Equivalent.

R204.3, R304.5.3, STD 1115
