# Access Compliance Report Public Rights-of-Way (Curb Ramps)

Main Street: MORNING\_TRAIL Cross Street: OSO\_PKWY Location: SW

ADA ID: RPRK211021123527 Ramp Type: Type 1 - Perpendicular Diagonal Initial Pass/Fail: Fail Overall Compliance: No Severity Score: 30

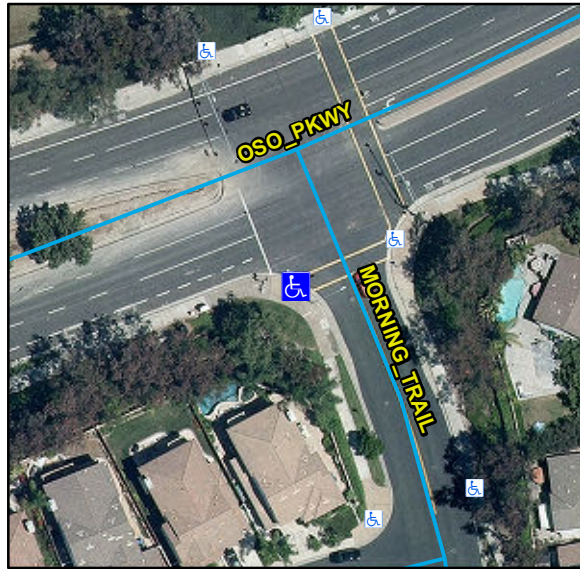
| Compliance | Description | Data | Compliance | Description | Data |
|---|---|---|---|---|---|
| No | Ramp Run Slope (%) | 10.2 | N/A | Flare Slope LT (%) | N/A |
| No | Ramp Cross Slope (%) | 5.4 | N/A | Flare Traversable LT | N/A |

Remove & Replace Curb Ramp With Two New Directional Ramps or Equivalent.
