# Access Compliance Report Public Rights-of-Way (Curb Ramps)

| Main Street: <b>OSO_PKWY</b> | | Cross Street: <b>MORNING_TRAIL</b> | | Location: <b>NE</b> |
| ADA ID: <b>RPRK211021124644</b> | Ramp Type: <b>Type 1 - Perpendicular</b> | Initial Pass/Fail: <b>Fail</b> | Overall Compliance: <b>No</b> | Severity Score: <b>30</b> |

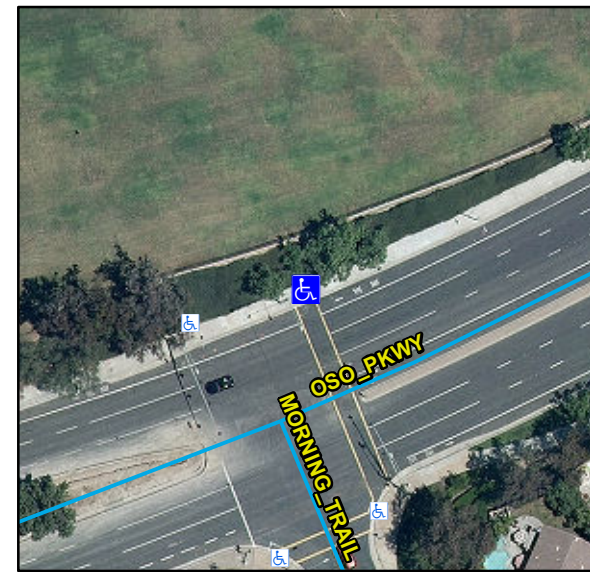
| Compliance | Description | Data | Compliance | Description | Data |
|---|---|---|---|---|---|
| <b>No</b> | Ramp Run Slope (%) | <b>8.5</b> | <b>N/A</b> | Flare Slope LT (%) | <b>N/A</b> |
| <b>No</b> | Ramp Cross Slope (%) | <b>6.4</b> | <b>N/A</b> | Flare Traversable LT | <b>N/A</b> |

**Remove & Replace Entire Ramp.**

**R304.2.2, R304.5.3, STD 1115**
