# Access Compliance Report Public Rights-of-Way (Curb Ramps)

Main Street: SIENNA\_PKWY Cross Street: SKYWOOD\_ST Location: S

ADA ID: RPRK211021142509 Ramp Type: Type 1 - Perpendicular Diagonal Initial Pass/Fail: Fail Overall Compliance: No Severity Score: 16

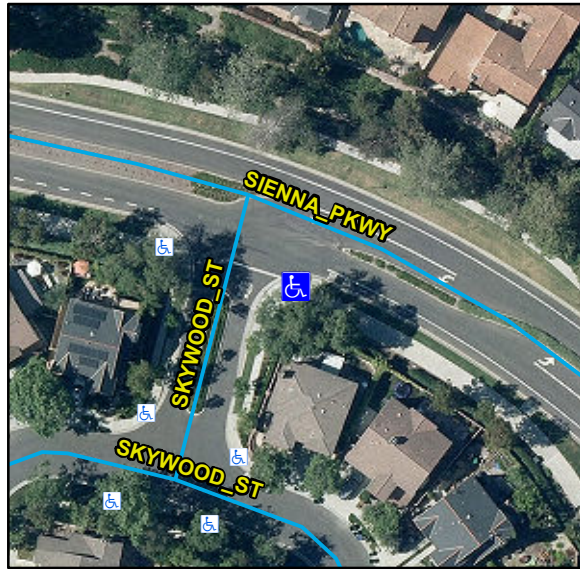
R304.2.2, R204.3, R304.5.3, STD 1115

| Compliance | Description | Data | Compliance | Description | Data |
|---|---|---|---|---|---|
| No | Ramp Run Slope (%) | 11.8 | N/A | Flare Slope LT (%) | N/A |
| No | Ramp Cross Slope (%) | 4 | N/A | Flare Traversable LT | N/A |

Remove & Replace Curb Ramp With Two New Directional Ramps or Equivalent.
