# Access Compliance Report Public Rights-of-Way (Curb Ramps)

Main Street: DANBURY Cross Street: MAYBECK\_LN Location: SE

ADA ID: RPRK211025112942 Ramp Type: Type 4 - Parallel Initial Pass/Fail: Fail Overall Compliance: No Severity Score: 2

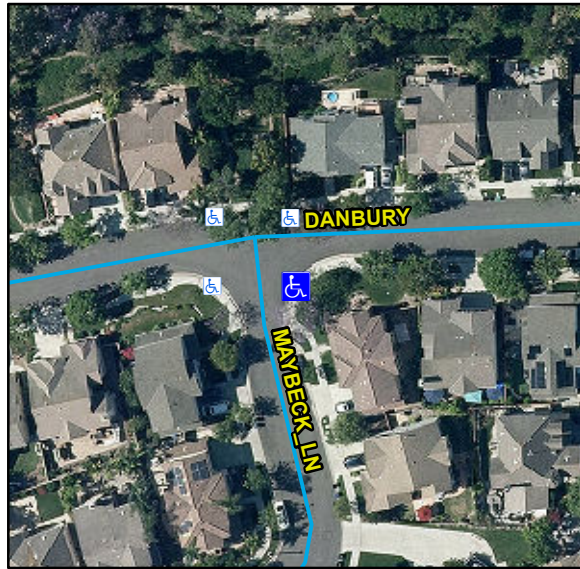
| Compliance | Description | Data | Compliance | Description | Data |
|---|---|---|---|---|---|
| No | Ramp Cross Slope LT (%) | 2.7 | Yes | Ramp Cross Slope RT (%) | 0.7 |
| N/A | Gutter Cross Slope (%) | N/A | No | Perpendicular Joint Present | No |

**Remove & Replace Curb Ramp With Two New Directional Ramps or Equivalent.**

**R204.3, R304.5.3, STD 1115**
