# Access Compliance Report Public Rights-of-Way (Curb Ramps)

| Main Street: MAYBECK_LN | | Cross Street: MAYBECK_LN | | Location: | W |
| ADA ID: RPRK211025114021 | Ramp Type: Type 1 - Perpendicular | Initial Pass/Fail: Fail | Overall Compliance: No | Severity Score: | 45 |

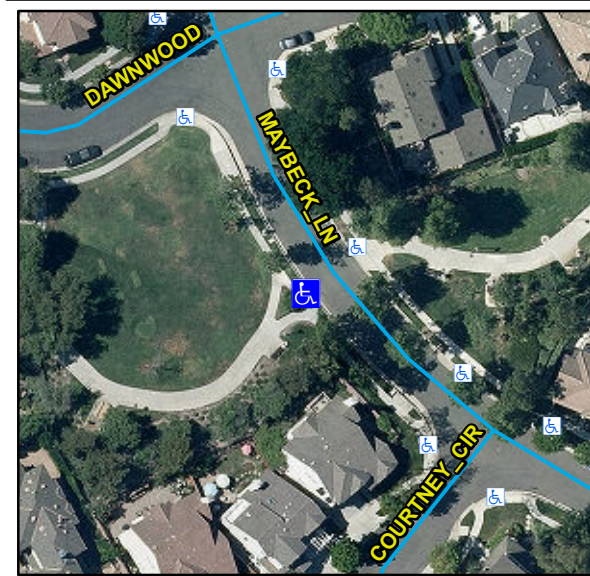
R204.3, R304.2.2, R304.5.3, STD 1115

| Compliance | Description | Data | Compliance | Description | Data |
|---|---|---|---|---|---|
| No | Ramp Run Slope (%) | 13.1 | N/A | Flare Slope LT (%) | N/A |
| No | Ramp Cross Slope (%) | 5.8 | N/A | Flare Traversable LT | N/A |

Remove & Replace Entire Ramp.
