# Access Compliance Report Public Rights-of-Way (Curb Ramps)

| Main Street: MAYBECK_LN | | Cross Street: MAYBECK_LN | | Location: | E |
| ADA ID: RPRK211025114144 | Ramp Type: Type 1 - Perpendicular | Initial Pass/Fail: Fail | Overall Compliance: No | Severity Score: | 2 |

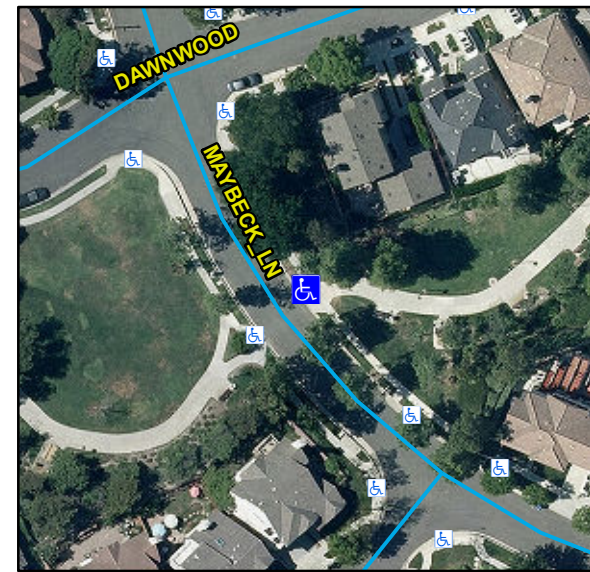
| Compliance | Description | Data | Compliance | Description | Data |
|---|---|---|---|---|---|
| No | Ramp Cross Slope (%) | 4.4 | N/A | Flare Traversable LT | N/A |
| N/A | Gutter Ponding | N/A | No | Curb Slope | 7.1 |

Remove & Replace Entire Ramp.
