# Access Compliance Report Public Rights-of-Way (Curb Ramps)

Main Street: DAWNWOOD Cross Street: MAYBECK\_LN Location: SE

ADA ID: RPRK211025114313 Ramp Type: Type 4 - Parallel Initial Pass/Fail: Fail Overall Compliance: No Severity Score: 30

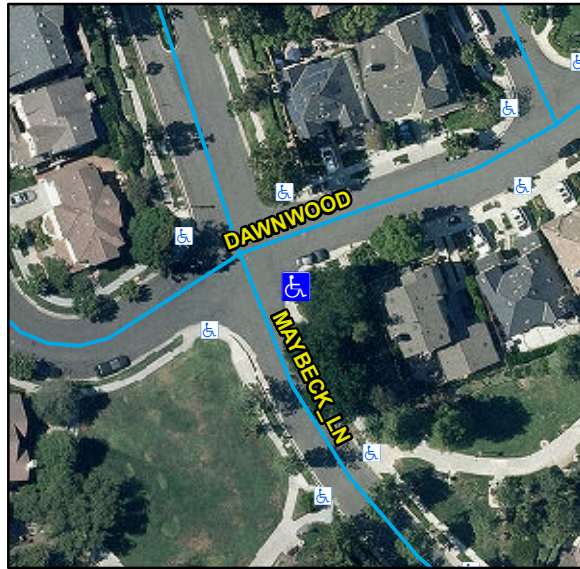
| Compliance | Description | Data | Compliance | Description | Data |
|---|---|---|---|---|---|
| Yes | Ramp Run Slope LT (%) | 3.2 | No | Ramp Run Slope RT (%) | 14.5 |

**Remove & Replace Curb Ramp With Two New Directional Ramps or Equivalent.**

**R204.3, R304.3.2, STD 1115**
