Access Compliance Report Public Rights-of-Way (Curb Ramps)

Main Street: ETON_PL **Cross Street:** ETON_PL **Location:** SE

ADA ID: RPRK211026144022 **Ramp Type:**Type 1 - Perpendicular **Initial Pass/Fail:** Fail **Overall Compliance:** No **Severity Score:** 16

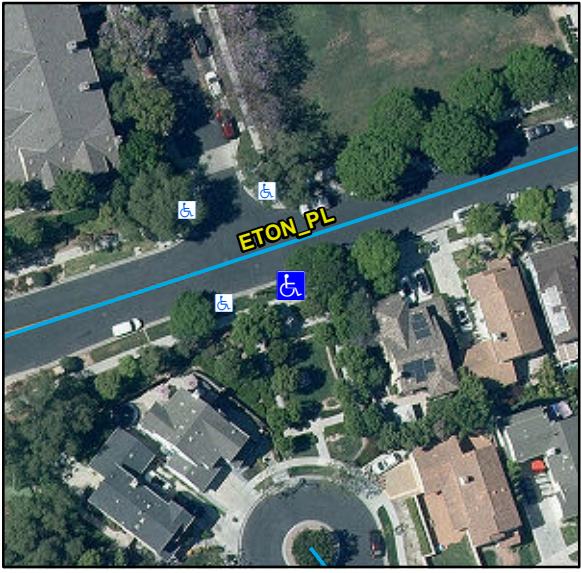
Compliance	Description	Data	Compliance	Description	Data
N/A	Ramp Length (in)	86	N/A	Flare Type LT	
Yes	Ramp Width (in)	48			N/A
No	Ramp Run Slope (%)	8.9	N/A	Flare Slope LT (%)	N/A
No	Ramp Cross Slope (%)	3.5	N/A	Flare Traversable LT	N/A
N/A	Landing Present	N/A	N/A	Flare Type RT	
N/A	Landing Length (in)	N/A			N/A
N/A	Landing Width (in)	N/A	N/A	Flare Slope RT (%)	N/A
N/A	Landing Run Slope (%)	N/A	N/A	Flare Traversable RT	N/A
N/A	Landing Cross Slope (%)	N/A	N/A	DWS Provided	N/A
N/A	Landing Movement Obstructed?	N/A	N/A	DWS Contrast	N/A
	Landing Movement Type	N/A	N/A	DWS Length (in)	N/A
N/A	Landing Shared	N/A	N/A	DWS Full Width	N/A
N/A	Clear Space	N/A	N/A	DWS Offset Left (in)	N/A
N/A	Clear Space To Crosswalk (in)	N/A	N/A	DWS Offset Right (in)	N/A
N/A	Marked Crosswalk 1	No	N/A	Marked Crosswalk 2	N/A
	Crossing 1 Direction	N		Crossing 2 Direction	N/A
	Marked Crosswalk 1 Width (in)	N/A		Marked Crosswalk 2 Width (in)	N/A

N/A	Ramp Inside Crosswalk 1	N/A	Yes	Ramp Inside Crosswalk 2	N/A
	Crossing 1 Slope (%)	0.6		Crossing 2 Slope (%)	N/A
	Crossing 1 Cross Slope (%)	1.8		Crossing 2 Cross Slope (%)	N/A
N/A	Gutter Ponding	N/A	N/A	Curb Slope	4.4
Yes	Gutter Lip Height (in)	0		Road Run Slope (%)	N/A
N/A	Gutter Run Slope (%)	N/A		Road Cross Slope (%)	N/A
N/A	Gutter Cross Slope (%)	N/A			
Yes	Overall Surface Condition: Acceptable		No	Perp Joint Present	No
	Cross Gutter Present?	No		Spandrel Present?	No
	Replace Cross Gutter?	N/A		Replace Spandrel?	N/A

Possible Solutions:
Remove & Replace Entire Ramp.
