# Access Compliance Report Public Rights-of-Way (Curb Ramps)

Main Street: WINDMILL\_AVE Cross Street: MERCANTILE\_WAY Location: SE

ADA ID: RPRK211029115711 Ramp Type: Type 1 - Perpendicular Initial Pass/Fail: Fail Overall Compliance: No Severity Score: 30

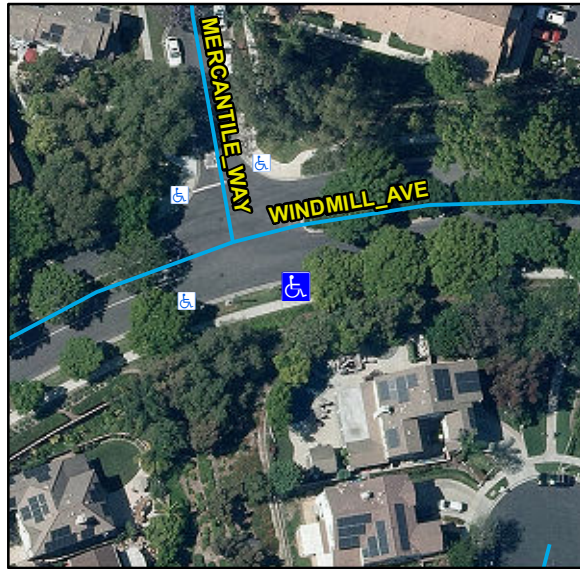
| Compliance | Description | Data | Compliance | Description | Data |
|---|---|---|---|---|---|
| No | Ramp Run Slope (%) | 9.9 | N/A | Flare Slope LT (%) | N/A |
| No | Ramp Cross Slope (%) | 6.9 | N/A | Flare Traversable LT | N/A |

Remove & Replace Entire Ramp.
