# Access Compliance Report Public Rights-of-Way (Curb Ramps)

Main Street: CECIL\_PASTURE\_RD Cross Street: CECIL\_PASTURE\_RD Location: W

ADA ID: RPRK211102124739 Ramp Type: Type 1 - Perpendicular Initial Pass/Fail: Pass Overall Compliance: Yes Severity Score: 0

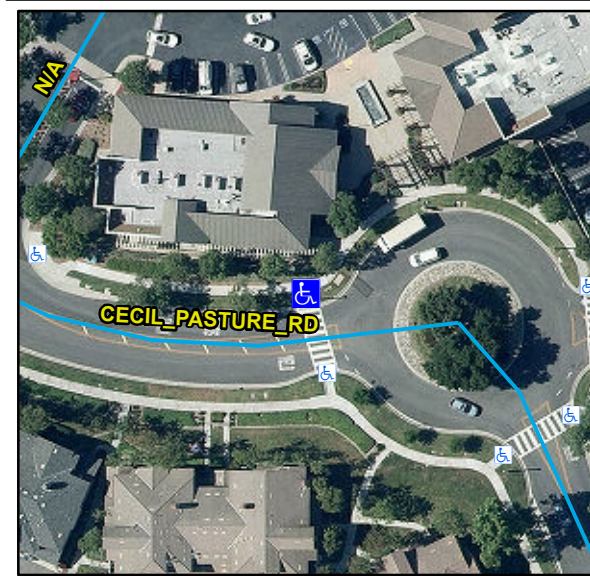
Surveyor Notes:  
N/A

Possible Solutions:  
N/A
