# Access Compliance Report Public Rights-of-Way (Curb Ramps)

| Main Street: S_SELLAS_RD | | Cross Street: TUBEROSE_ST | | Location: | NW |
| ADA ID: RPRK211103140821 | Ramp Type:Type 1 - Perpendicular | Initial Pass/Fail: Fail | Overall Compliance: No | Severity Score: | 15 |

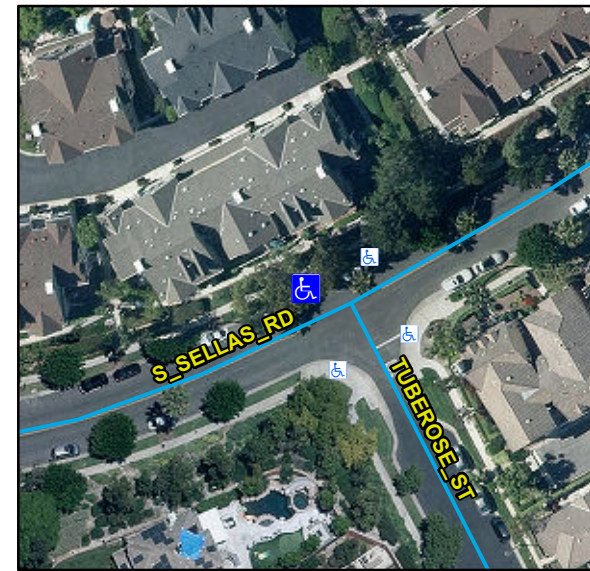
R304.2.2, STD 1115

| Compliance | Description | Data | Compliance | Description | Data |
|---|---|---|---|---|---|
| No | Ramp Run Slope (%) | 10.4 | N/A | Flare Slope LT (%) | N/A |

Remove & Replace Entire Ramp.
