# Access Compliance Report Public Rights-of-Way (Curb Ramps)

Main Street: MOCHA\_LN Cross Street: LODEN\_PASS Location: W

ADA ID: RPRK211104130709 Ramp Type: Type 1 - Perpendicular Initial Pass/Fail: Fail Overall Compliance: No Severity Score: 16

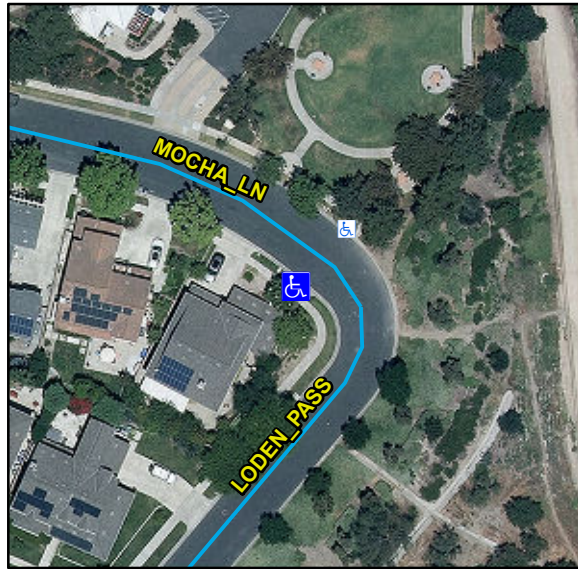
| Compliance | Description | Data | Compliance | Description | Data |
|---|---|---|---|---|---|
| No | Ramp Run Slope (%) | 9 | N/A | Flare Slope LT (%) | N/A |

Remove & Replace Entire Ramp.
