# Access Compliance Report Public Rights-of-Way (Curb Ramps)

Main Street: TAFFETA\_LN Cross Street: LODEN\_PASS Location: N

ADA ID: RPRK211104130809 Ramp Type: Type 4 - Parallel Initial Pass/Fail: Fail Overall Compliance: No Severity Score: 15

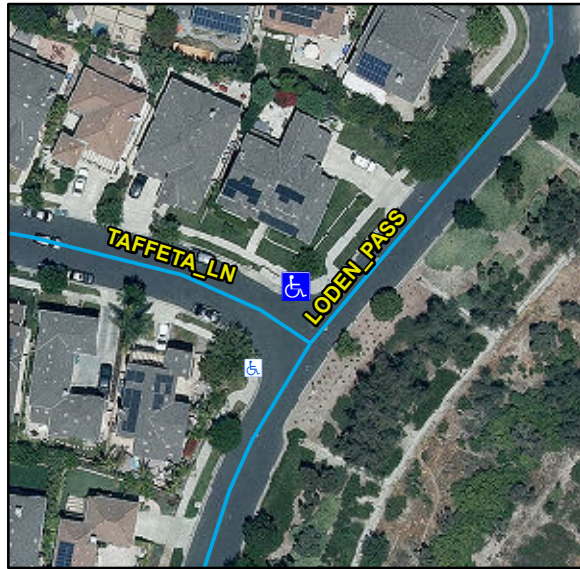
| Compliance | Description | Data | Compliance | Description | Data |
|---|---|---|---|---|---|
| Yes | Ramp Run Slope LT (%) | 0.1 | No | Ramp Run Slope RT (%) | 8.7 |

Remove & Replace Curb Ramp With Two New Directional Ramps or Equivalent.
