# Access Compliance Report

## Public Rights-of-Way

### (Curb Ramps)

Main Street: LODEN\_PASS Cross Street: TAFFETA\_LN Location: W

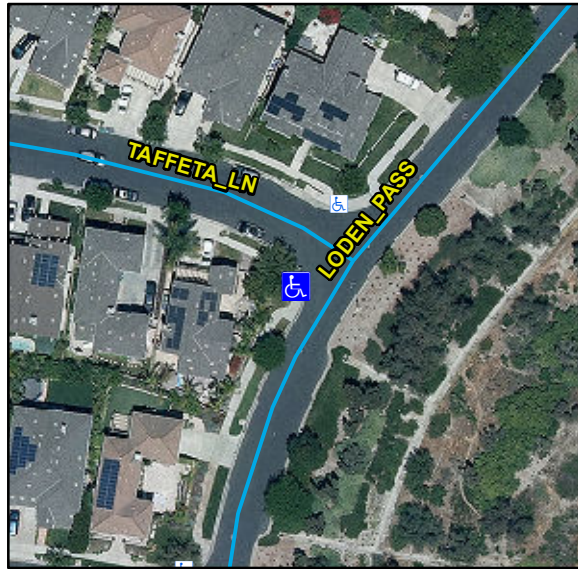
ADA ID: RPRK211104131035 Ramp Type: Type 4 - Parallel Initial Pass/Fail: Fail Overall Compliance: No Severity Score: 2

| Compliance | Description | Data | Compliance | Description | Data |
|---|---|---|---|---|---|
| No | Ramp Cross Slope LT (%) | 2.7 | No | Ramp Cross Slope RT (%) | 2.6 |

**Remove & Replace Curb Ramp With Two New Directional Ramps or Equivalent.**

**R304.5.3, STD 1115**

Total Cost: \$ 4000
