# Access Compliance Report Public Rights-of-Way (Curb Ramps)

| Main Street: SUGARCANE_LN | | Cross Street: LODEN_PASS | | Location: | N |
| ADA ID: RPRK211104131243 | Ramp Type: Type 4 - Parallel | Initial Pass/Fail: Fail | Overall Compliance: No | Severity Score: | 15 |

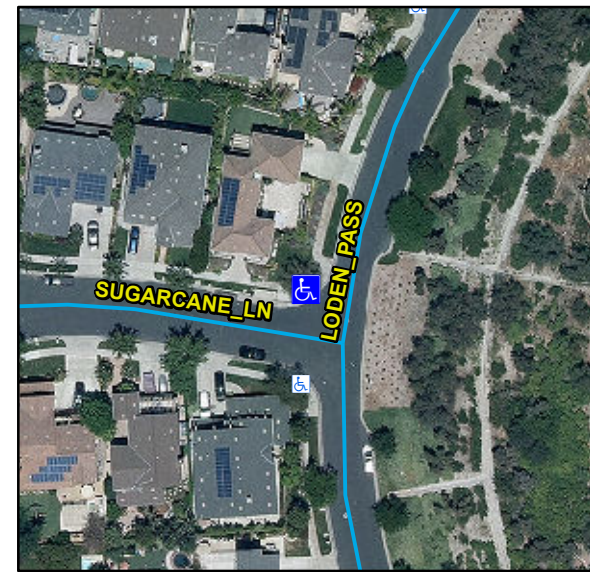
| Compliance | Description | Data | Compliance | Description | Data |
|---|---|---|---|---|---|
| Yes | Ramp Run Slope LT (%) | 1.6 | No | Ramp Run Slope RT (%) | 9.6 |

**Remove & Replace Curb Ramp With Two New Directional Ramps or Equivalent.**

**R204.3, R304.3.2, STD 1115**
