# Access Compliance Report Public Rights-of-Way (Curb Ramps)

Main Street: BEACH\_POINT Cross Street: BUSHWOOD\_CIR Location: NW

ADA ID: RPRK211104135212 Ramp Type: Type 4 - Parallel Initial Pass/Fail: Fail Overall Compliance: No Severity Score: 16

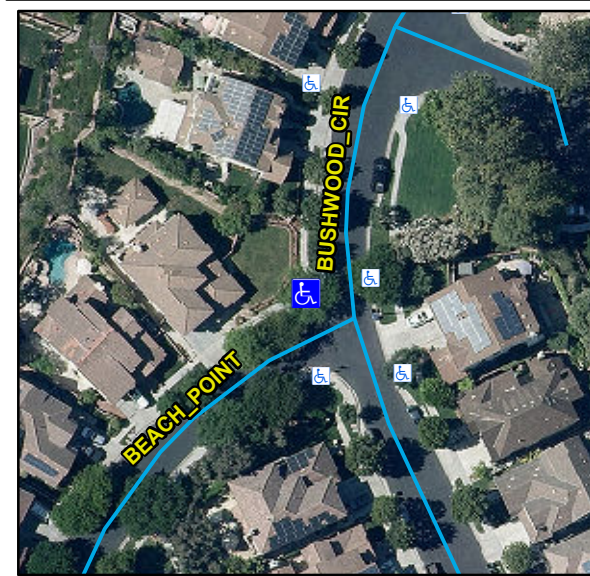
| Compliance | Description | Data | Compliance | Description | Data |
|---|---|---|---|---|---|
| Yes | Ramp Run Slope LT (%) | 3.5 | No | Ramp Run Slope RT (%) | 9.7 |
| No | Ramp Cross Slope LT (%) | 3.2 | No | Ramp Cross Slope RT (%) | 3.9 |

Possible Solutions:  
**Remove & Replace Curb Ramp With Two New Directional Ramps or Equivalent.**

OC Std/PROW:  
**R204.3, R304.5.3, R304.3.2, STD 1115**

Total Cost: \$ 4000
