# Access Compliance Report Public Rights-of-Way (Curb Ramps)

Main Street: N\_SELLAS\_RD Cross Street: SIENNA\_PKWY Location: SE

ADA ID: RPRK211109124838 Ramp Type: Type 1 - Perpendicular Initial Pass/Fail: Fail Overall Compliance: No Severity Score: 15

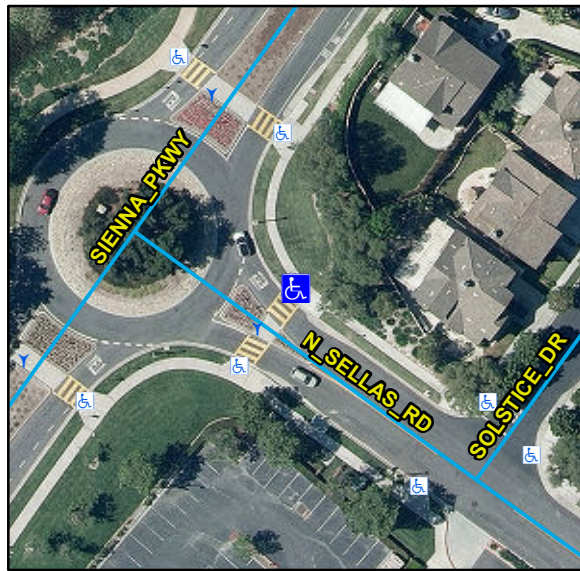
| Compliance | Description | Data | Compliance | Description | Data |
|---|---|---|---|---|---|
| No | Ramp Run Slope (%) | 9.8 | N/A | Flare Slope LT (%) | N/A |
| N/A | Gutter Ponding | N/A | No | Curb Slope | 11 |

Remove & Replace Entire Ramp.

R304.2.2, R204.3, STD 1115
