# Access Compliance Report Public Rights-of-Way (Curb Ramps)

| Main Street: SIENNA_PKWY | | Cross Street: N_SELLAS_RD | | Location: | E |
| ADA ID: RPRK211109125037 | Ramp Type: Type 1 - Perpendicular | Initial Pass/Fail: Fail | Overall Compliance: No | Severity Score: | 15 |

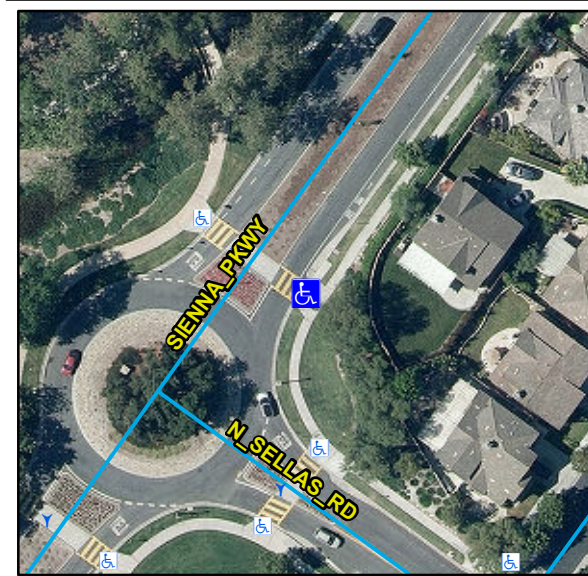
| Compliance | Description | Data | Compliance | Description | Data |
|---|---|---|---|---|---|
| No | Ramp Run Slope (%) | 9.7 | N/A | Flare Slope LT (%) | N/A |
| N/A | Gutter Ponding | N/A | No | Curb Slope | 8.4 |

**Remove & Replace Entire Ramp.**

**R304.2.2, R204.3, STD 1115**
