# Access Compliance Report Public Rights-of-Way (Curb Ramps)

| Main Street: N_SELLAS_RD | | Cross Street: SIENNA_PKWY | | Location: | SE |
| ADA ID: RPRK211109130159 | Ramp Type:Type 1 - Perpendicular | Initial Pass/Fail: Fail | Overall Compliance: No | Severity Score: | 15 |

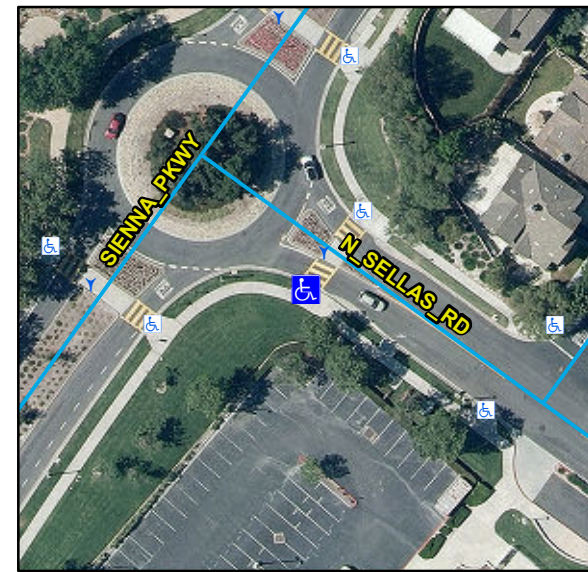
| Compliance | Description | Data | Compliance | Description | Data |
|---|---|---|---|---|---|
| No | Ramp Run Slope (%) | 9.4 | N/A | Flare Slope LT (%) | N/A |
| N/A | Gutter Ponding | N/A | No | Curb Slope | 11.6 |

**Remove & Replace Entire Ramp.**

**R304.2.2, R204.3, STD 1115**

Total Cost: \$ 3080
