# Access Compliance Report Public Rights-of-Way (Curb Ramps)

| Main Street: SIENNA_PKWY | | Cross Street: N_DAISSY_ST | | Location: | N |
| ADA ID: RPRK211110130139 | Ramp Type:Type 1 - Perpendicular | Initial Pass/Fail: Fail | Overall Compliance: No | Severity Score: | 16 |

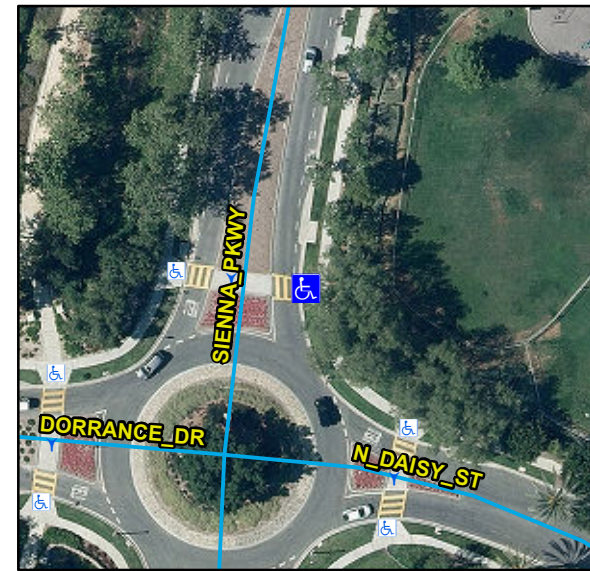
| Compliance | Description | Data | Compliance | Description | Data |
|---|---|---|---|---|---|
| No | Ramp Run Slope (%) | 8.8 | N/A | Flare Slope LT (%) | N/A |
| N/A | Gutter Ponding | N/A | No | Curb Slope | 8.6 |

Remove & Replace Entire Ramp.
