# Access Compliance Report Public Rights-of-Way (Curb Ramps)

Main Street: CLYDESDALE\_DR Cross Street: COUSTEAU\_LN Location: SE

ADA ID: RPRK211110134957 Ramp Type: Type 1 - Perpendicular Initial Pass/Fail: Fail Overall Compliance: No Severity Score: 15

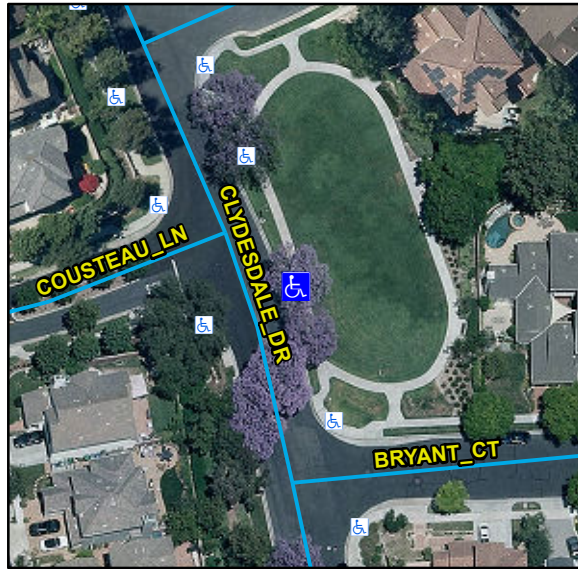
R304.2.2, R204.3, STD 1115

| Compliance | Description | Data | Compliance | Description | Data |
|---|---|---|---|---|---|
| No | Ramp Run Slope (%) | 9.9 | N/A | Flare Slope LT (%) | N/A |
| N/A | Gutter Ponding | N/A | No | Curb Slope | 12.1 |

Remove & Replace Entire Ramp.
